PML GM 6L80/6L80E Stock Capacity Transmission Pan Verify Level Check BEFORE Installation

PML Part Number 11087

→This applies only to some vehicles. Check OEM stock pan.←

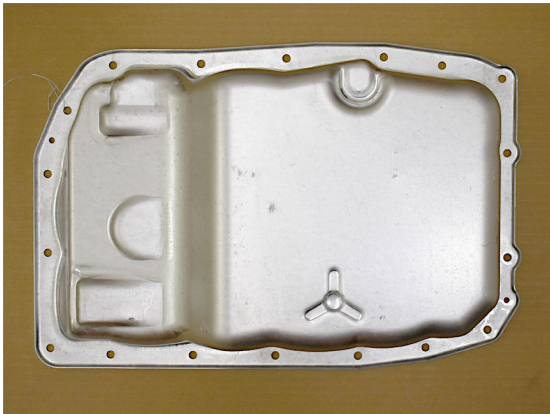
This document DOES NOT APPLY if the stock pan does NOT have a fill/level check at the rear of the pan. Example pictured at left. This is common with pre-2019 trucks and SUVs.

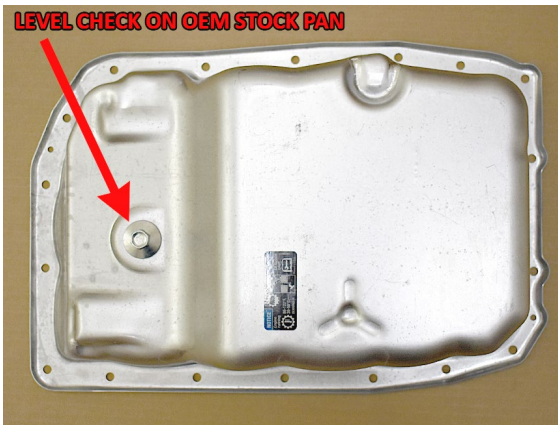
This document DOES APPLY if the stock pan HAS a fill/level check at the rear of the pan. Example pictured left.

The fill/level check hole is at the rear of the pan.

Verify that the PML pan level check matches the stock pan before installing if your vehicle uses the fill/level check hole on the transmission pan.

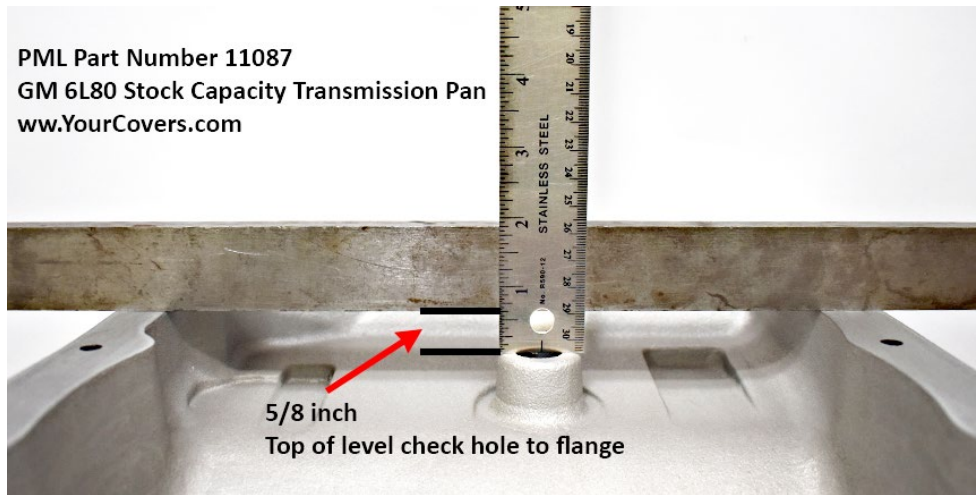
By default, this PML transmission pan has the level check is 5/8" below the flange. This can be machined to match the OEM pan. Call or email for information.

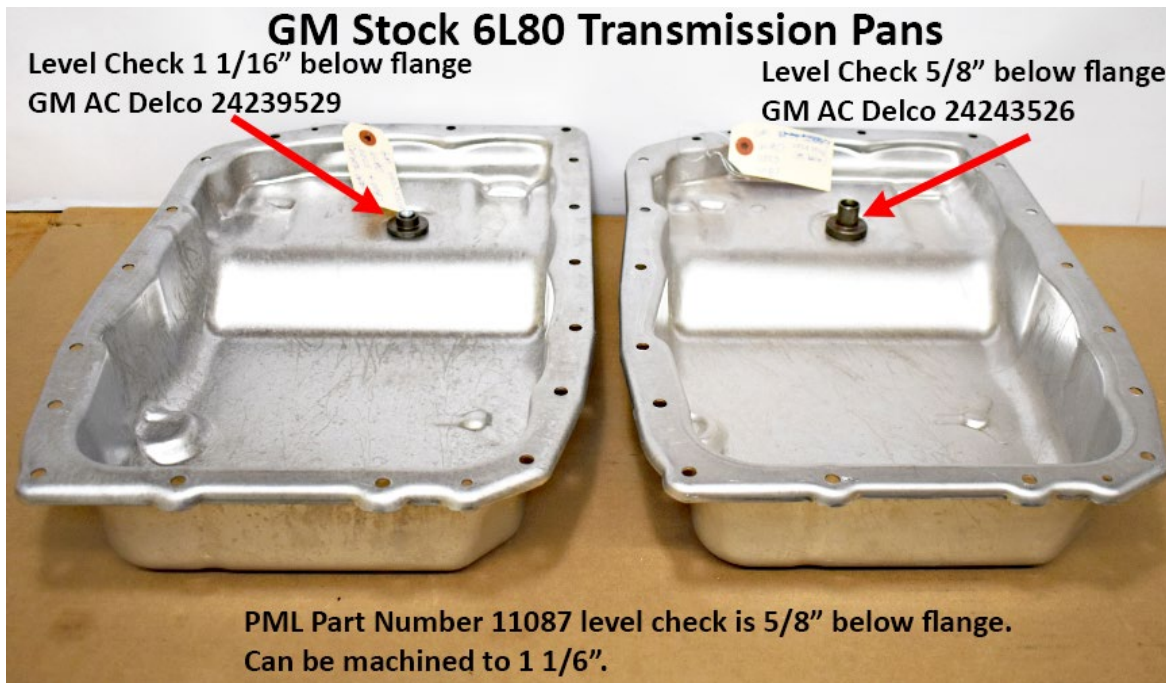
These two OEM stock pans have different heights from the flange to the top of the level check hole. Other OEM pans may have other heights.

There could also be a problem with the PML pan hitting transmission internals if the heights do not match. So it is important to check the distance before installing.
